Test Report

No.: SDHL1812029441FT

Sample Description : OFFICE CHAIR 3
 Supplier Item No. : MS8007GATL-A-BK
 Manufacturer : ZONMAN FURNITURE LIMITED
 Supplier : ZONMAN FURNITURE LIMITED
 Sample Receiving Date : Dec.26, 2018
 Test Performing Date : Dec.27, 2018 to Jan.03, 2019

Test(s) Requested	Result(s)
Clause 5, 7, 12 and 13 of ANSI/BIFMA X5.1-2017 (Type I, III)	PASS

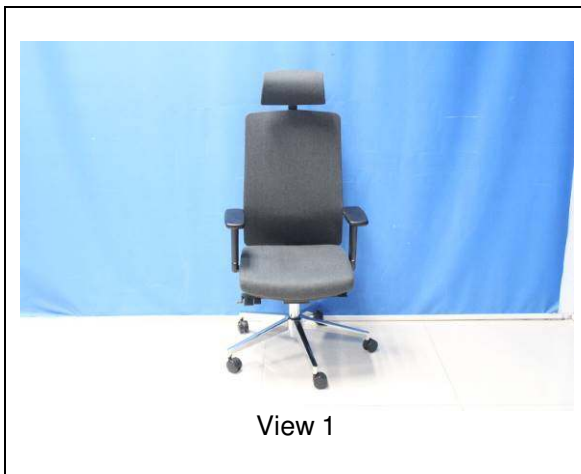
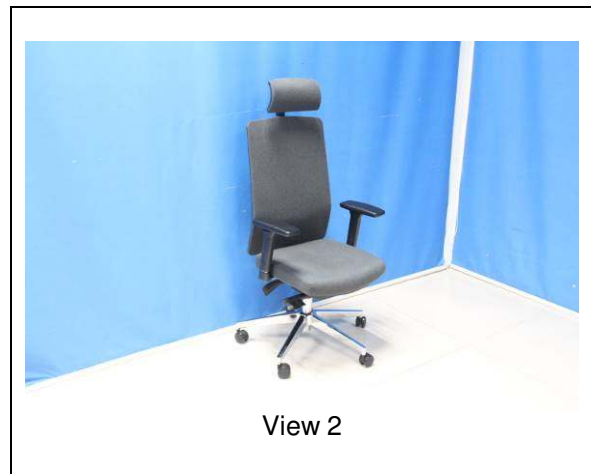
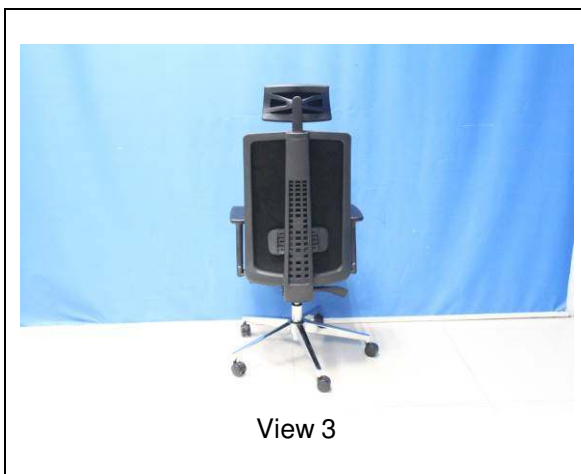
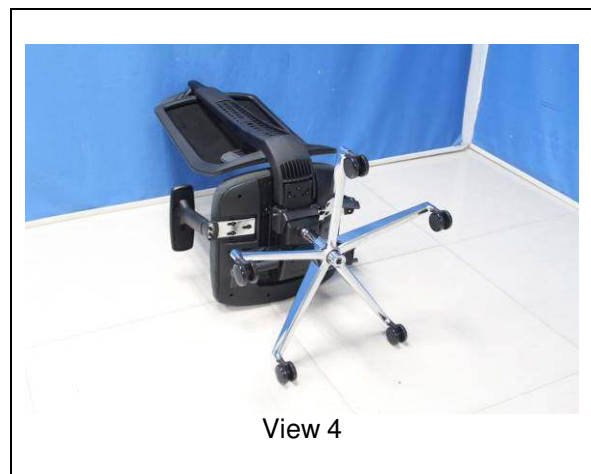
Sample as Received

SAMPLE INFORMATION AND PICTURES

Weight: 19.05 kg

Overall Dimensions: 715~775 mm D x 740 mm W x 1260~1395 mm H

Other Dimensions: Base radius, 345 mm
